# Manhole Inspection Summary

Manhole # S07WW1007MH

Insp Date: **9/12/06 10:53 AM**

**Location** Address: **3010 MANHATTAN AVE**

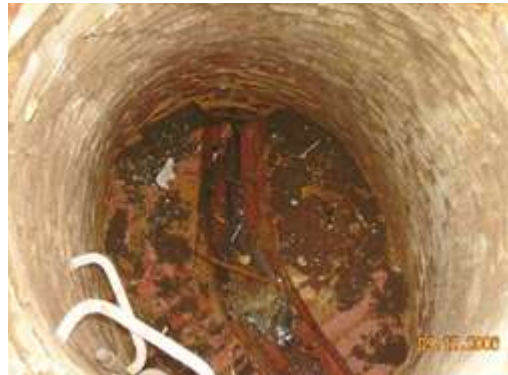
Top View

**Bench** ☒ Exists Material: **Brick** ☐ Parged ☒ **Debris** (not Condition related)

**Surcharge** ☒ **Evidence Of Surcharge** Depth: **1** (ft.) ☐ Active Surcharge Present

Evidence of surcharge - Bench debris.  
Channel debris.

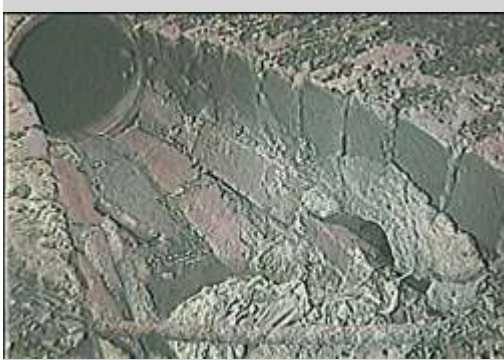
Defect

Condition: ☐ Sound ☐ Cracked ☐ Root Intrusion ☒ **Deteriorated** ☐ Leaks ☒ **Debris**

Channel deterioration and debris.

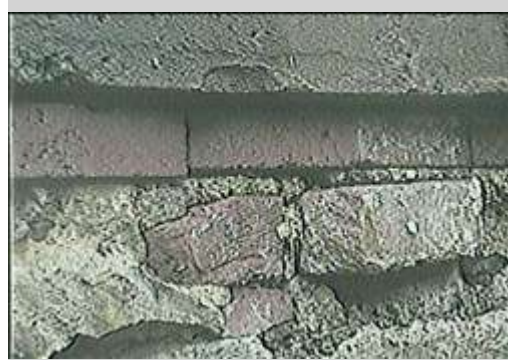
Defect

Condition: ☐ Sound ☐ Cracked ☐ Root Intrusion ☒ **Loose Brick** ☒ **Deteriorated**

Infiltration: ☐ None ☒ **Joint** ☐ Cracks ☒ **Mortar** ☐ Roots ☐ Wall

Frame leaks. Adjustment deterioration,  
loose brick, and infiltration.

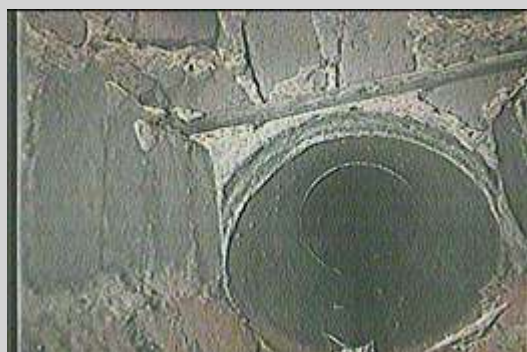
Pipe Out @ 12 O'Clock

Deposits: ☐ None ☐ Mud ☐ Sludge ☒ **Debris** ☐ **Grease**

Silt Depth: **0** (in.) Deposits Extent: **Light**

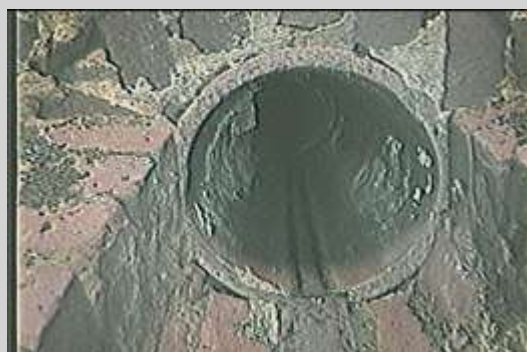
Pipe In @ 5 O'Clock

Deposits: ☐ None ☐ Mud ☐ Sludge ☐ Debris ☒ **Grease**

Silt Depth: **0** (in.) Deposits Extent: **Light**
